Using NDT Techniques to Detect and Characterise the Damage of End-Of-Life Components in Remanufacturing

Fatma Ocal¹, Yuchun Xu²,

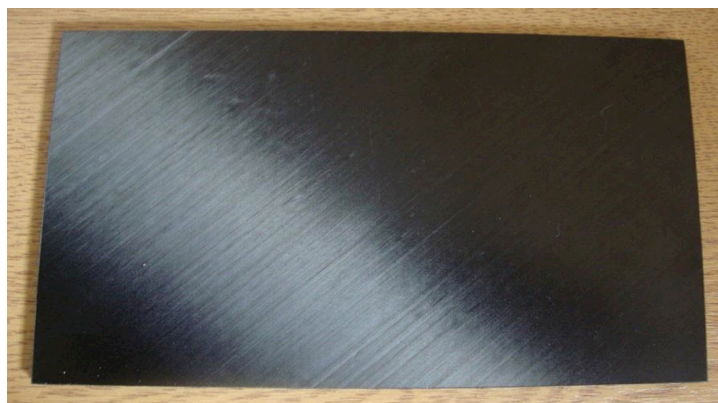
Figure 1: Composite specimen with Damage of Delamination

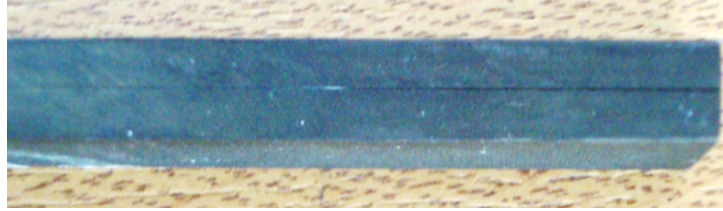
Figure 2: Composite Specimen with sampler damage of crack

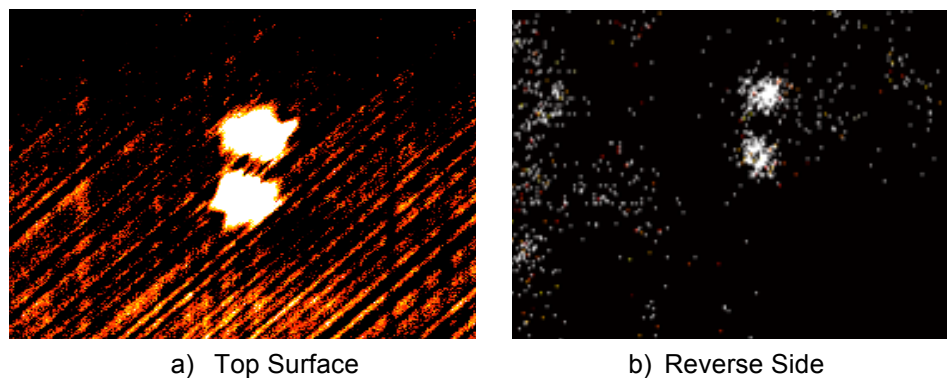
Thermographic Inspection captured IR images that revealed two separate subsurface delaminations are found in the impact damage test specimen as shown from the top surface and reverse surface of the specimen in Figure 3.

Figure 3: IR imaging of the impact damage specimen from the: a) top surface and b) reverse side

The top surface of the specimen resulted in a clearer image of the two delaminations when compared to the image from the reverse side. This indicates that the delaminations are closer to the top surface. The defects were quantified in two dimensions using the captured image. The two delaminations were approximately circular and these results are tabulated in Table 1.

Defect	Length (mm)	Width (mm)
Top Delamination	12.322	11.227
Bottom Delamination	12.884	12.221

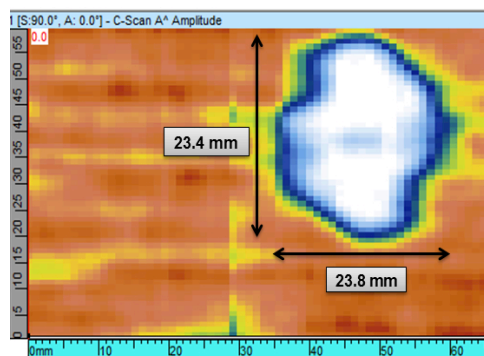
resolution image that presented the specimen feature. It was found that there is a large defect within the specimen that is seen in white colour in the image. The approximate length and width of the damaged area was measured.

Figure 4: Phased array c-scan of the material surface

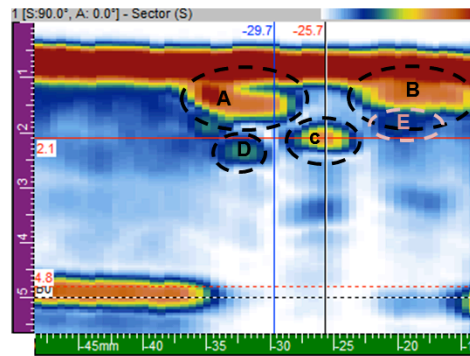
While moving the cursor over detected damage area, B-scan view on the flaw detector displayed a cross-sectional view and it was revealing the existence of other surface and sub-defects. The B-scan view facilitated measurement of the depth of any existing defect. There were five delaminations detected within the composite with different depths as seen in Figure 5. Images of each delamination cross-section were taken and the length, width, and depth were measured. These images were obtained by cross-sectional cursor to reveal each defect.

Figure 5: Cross-sectional view showing five delaminations

Defect	Length (mm)	Width (mm)	Depth (mm)
A	19.4	8.5	0.8
B	18.3	9.5	0.6
C	13	6.6	1.4
D	15.1	10.3	1.4
E	9.8	3.7	1.7

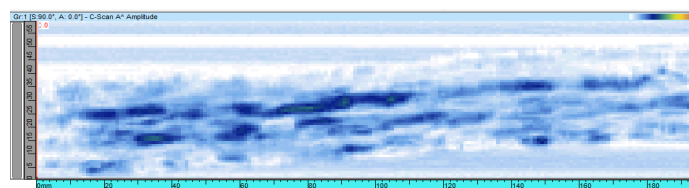
Figure 8 is the phased array C-scan image of the double cantilever beam specimen captured from PA testing. The test specimen's thickness is found by measuring the distance from the top and bottom surface signals. The thickness was calculated to be 5.7 mm, which is the same as the thickness measured with a caliper.

Figure 8: Phased Array C-scan view of the entire specimen

As visually the crack was seen, the depth is 2.9 mm below the composite surface and its width is the same as the specimen width of 20 mm as the crack is seen from both sides of the specimen. The length of the crack is measured by moving cursor on the C-scan image to view different B-scan images. The distance between B-scan images where the defect is seen was 112.3 mm and listed in Table 3.

Defect	Length (mm)	Depth (mm)
Crack	112.3	2.9
